# MASTER PLAN

## STATE FARMERS MARKET

June 21, 2019

During September 2018, HH Architecture conducted a limited physical condition review and site assessment of the North Carolina State Farmers Market (SFM) buildings and campus as a first step in a larger master planning process. The purpose of this Facility Condition Assessment (FCA) report is to provide the NCDA&CS and SFM leadership with an overarching evaluation the SFM campus and constituent buildings in order to inform decision-making during master planning. This is a high-level assessment, directed to assess the safety, function, condition, and aesthetic knowns of the campus buildings and their programmatic relationships.

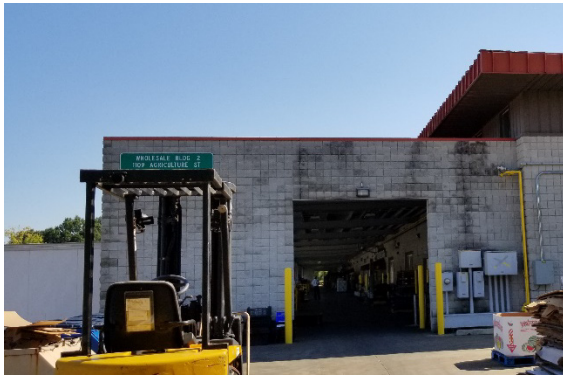
The condition of each building exterior depends mainly on the type of use and amount of traffic. Most buildings display appropriate signs of age such as fading factory finishes and organic growth on shaded and damp areas.

*Photo 1 – Organic Growth on Split-Face Block*

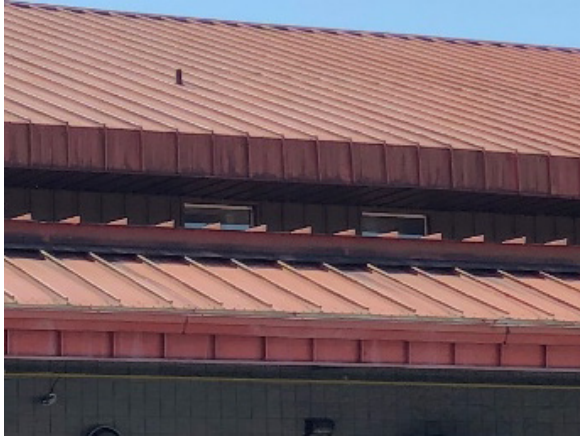
*Photo 2 - Example - Organic Growth on North Side of Roof*

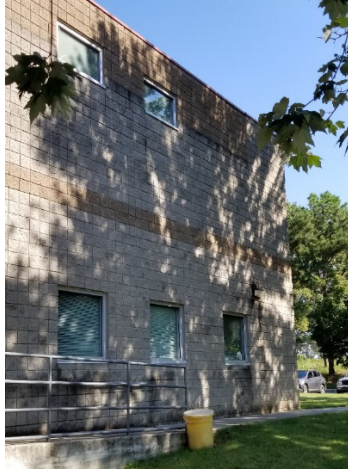
Block and mortar appear to be in good condition. The walls do display signs of organic growth, most notably on the north side of the building (*see photo 4*).

*Photo 4- L&M South Elevation showing signs of organic growth.*

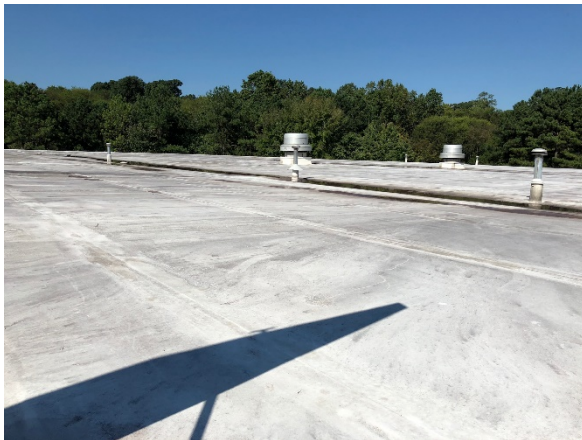
It appears that the roof is original to the building and is nearing the end of its lifespan. While no leaks in the membrane were observed, degradation of the membrane is apparent of the whole surface of the roof (see photos 5&6). The existing roof drainage appears to be in good working order.

*Photo 5- Single-ply roofing intact with no reported leaks*

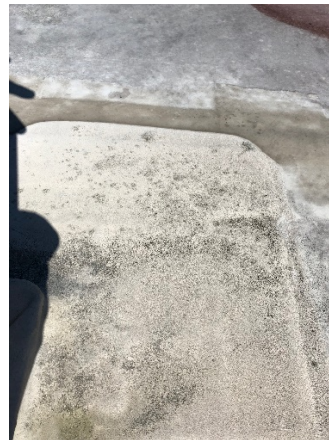
*Photo 6- Roofing wear and degradation*

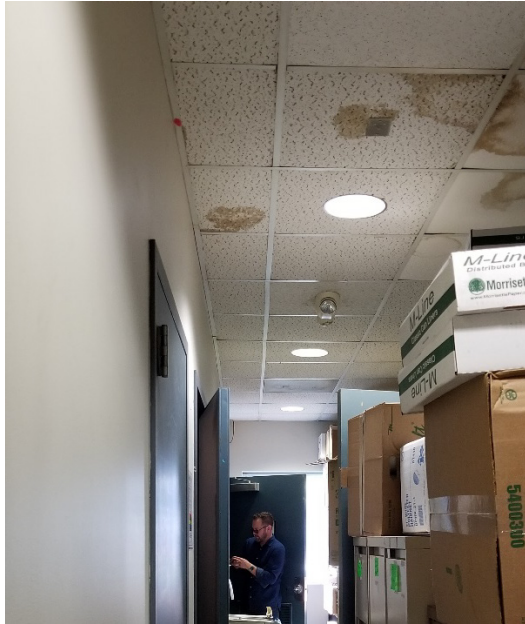
- 1) Administrative Offices- This area employs typical gypsum wall construction with acoustical panel ceilings, vinyl composition flooring, and hollow metal doors and view glazing. All finishes are in fair to poor shape from general wear and tear.

*Photo 7- Administrative Hallway- Stained APC*

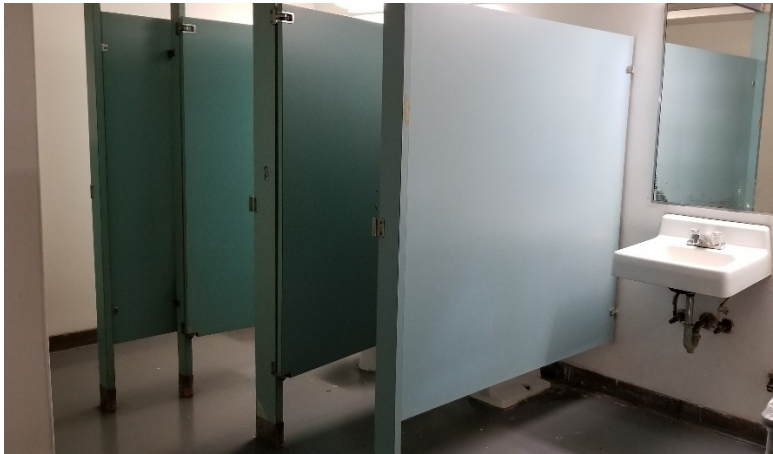
- 3) Mezzanine- The mezzanine houses worker break areas and restrooms with a slightly higher level of finish than the wholesale area proper. Restrooms have old fixtures and partitions that are delaminating and should be replaced.

*Photo 11 – Interior Finishes – Mezzanine Level*

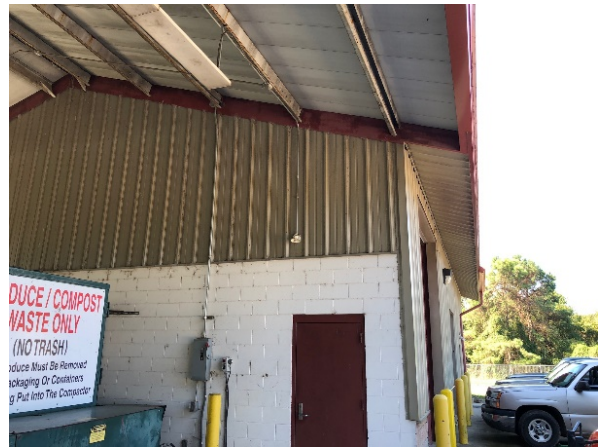
Photo 16 – Organic Growth on CMU

Block and mortar appear to be in good condition, but display signs of organic growth, most notably on the north side of the building (see photo 16).

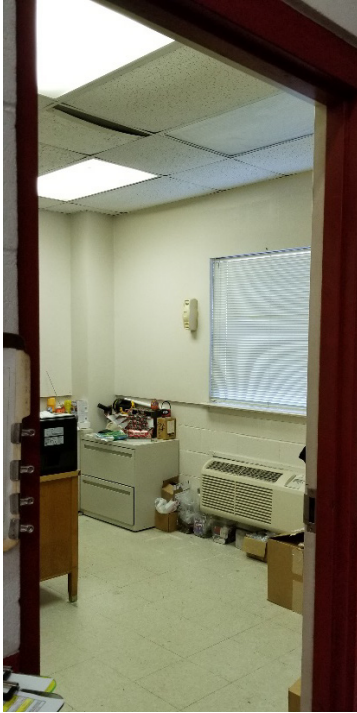
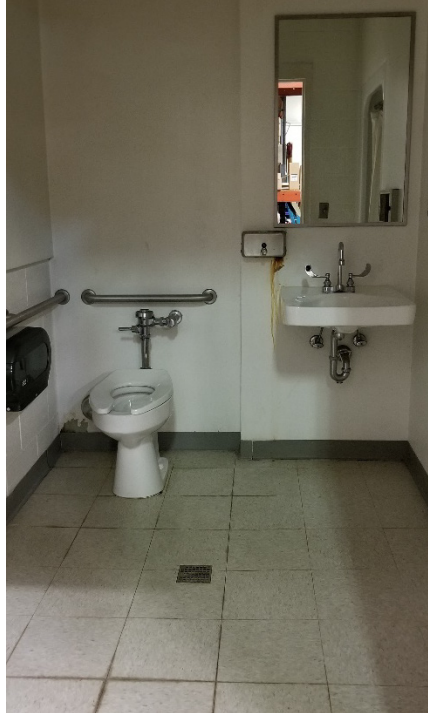
One office, one, break room, and two restrooms have vinyl composition finished floors and acoustical panel ceilings. Floor and ceilings in all finished locations are deteriorating and in need of replacement. Residential style cabinets in the breakroom are in poor condition and need replacement.

*Photo 17 & 18 – Office and Restroom Interiors in Maintenance Shed*

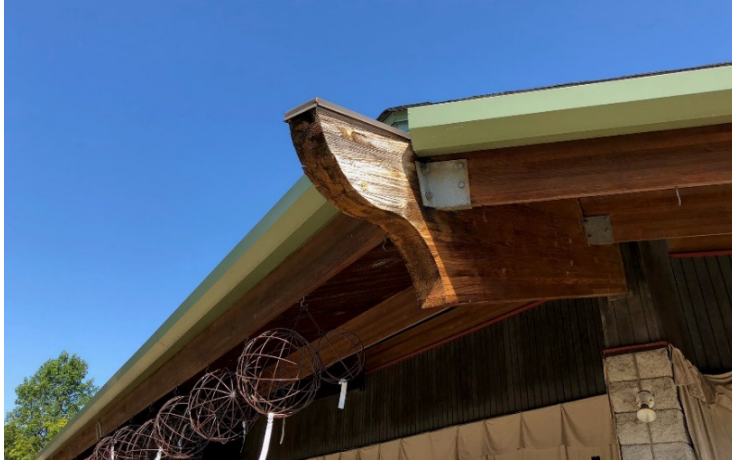
The wood siding contains weathering and bleaching at exposed locations. The ends of the glue-lam heavy timber beams are starting to fray and slightly separate where exposed. The areas underneath the protection of the large overhang are in good condition (*see photo 21*).

*Photo 21 – Weather ends of Glue-Lam Beams*

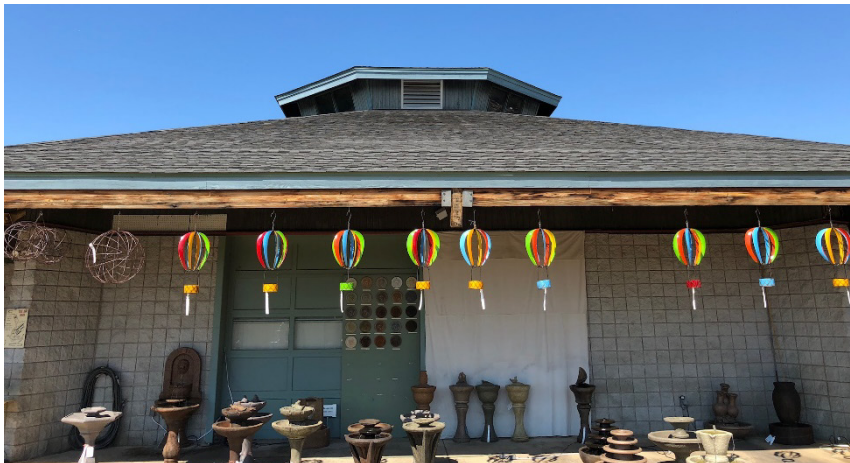
*Photo 22 – Exterior of Market Imports*

The roof appears to be near the end of its life expectancy and should be replaced soon.

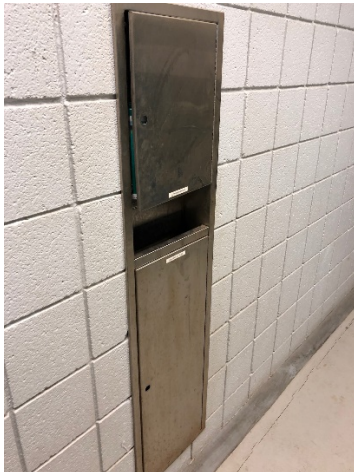
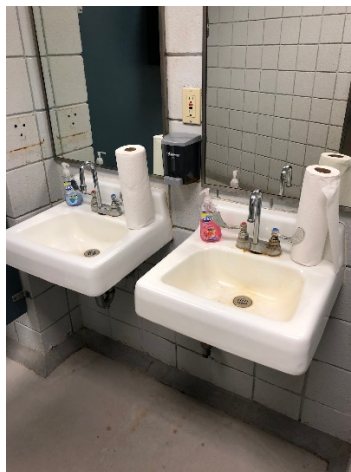
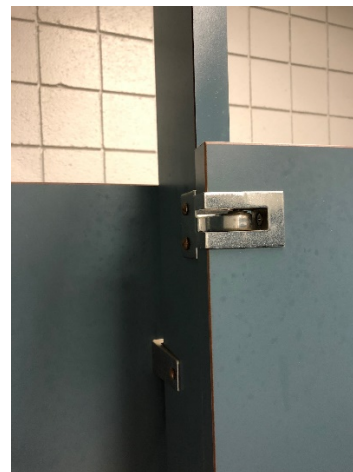
Most finishes in the interior of the building are in fair condition. The fixtures in the restrooms are in poor condition and should be replaced. The restroom partitions are in fair condition and are nearing the end of their useful lifecycle. The paint in the restrooms and office are in fair condition.

*Photo 24, 25, & 26 – Restroom Interiors and Fixtures in Market Imports*

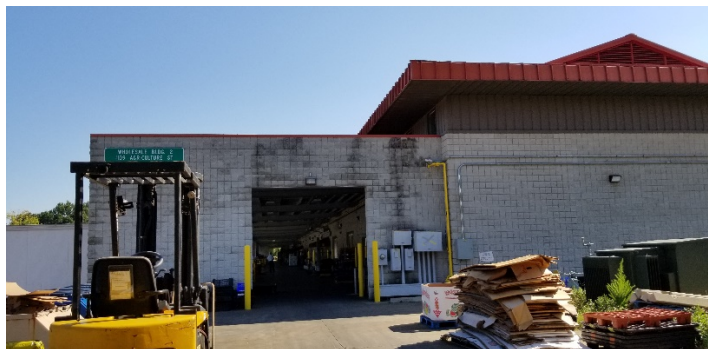
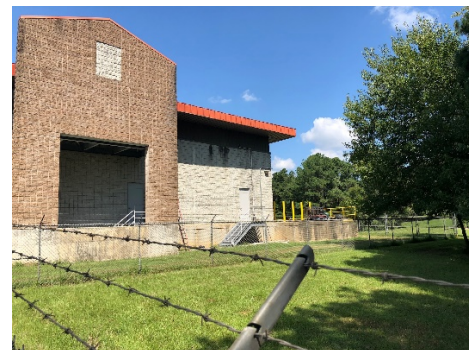
The block and mortar appear to be in good condition but display signs of organic growth in select locations. (see photos 31 and 32). The concrete plinth on the south façade of the building is also stained (see photo 32).

*Photo 31 & 32 – Wholesale Building Exterior – Staining and Organic Growth Evident*

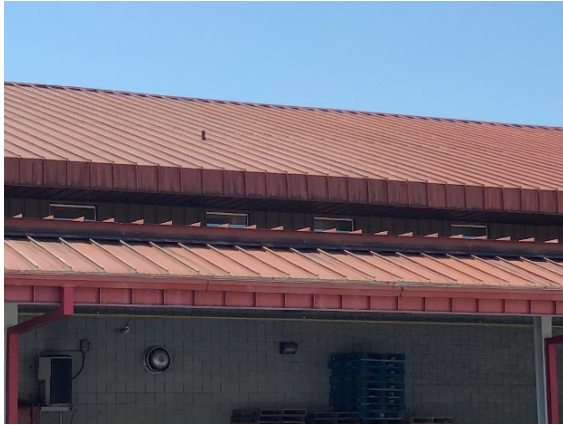
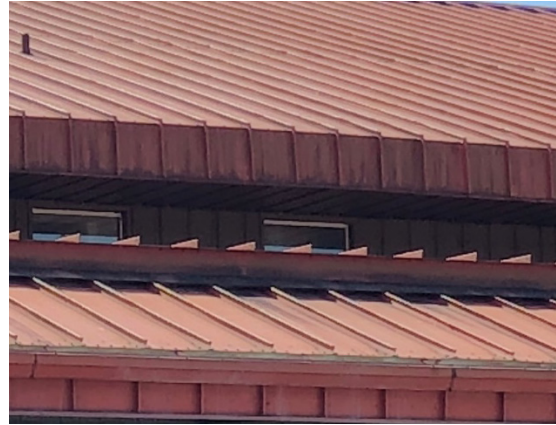
The color of the wholesale roof has faded from red to a peach-red color. The north face of the roof has organic growth that needs to be addressed (*see photo 34*).

*Photos 33 & 34 – Warehouse Roofing – Organic Growth Evident*

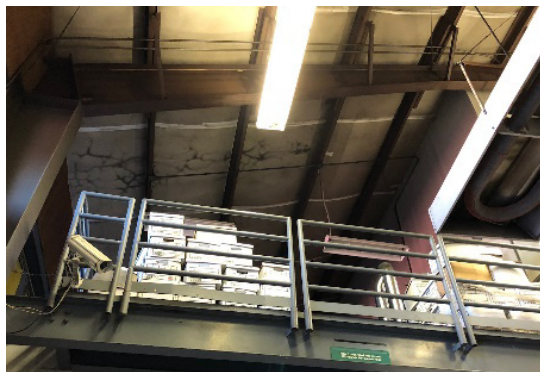
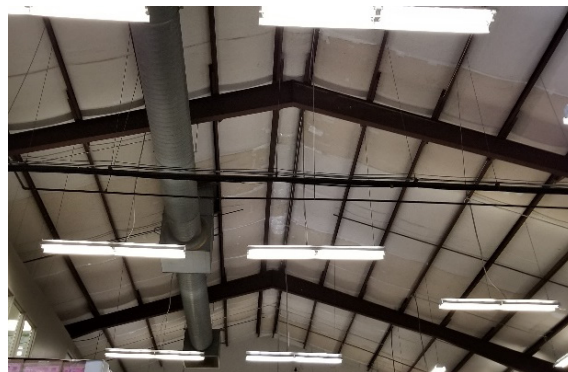
The exposed blanket insulation is torn and stained in many areas of the wholesale buildings (*see photos 37 & 38*).

*Photo 37 & 38 – Interior Insulation Conditions*

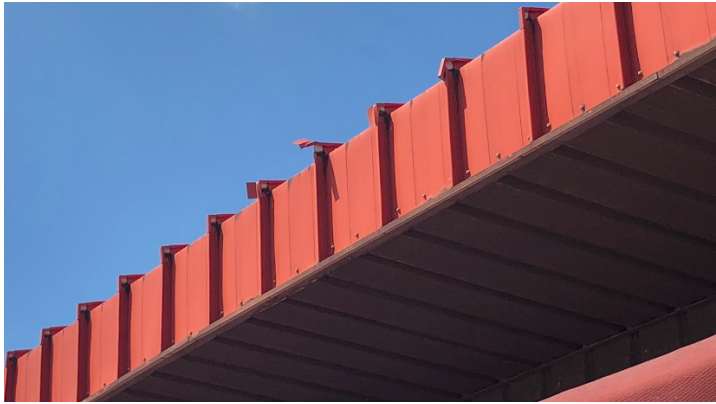
*Photo 46 – Seafood Restaurant Roof in need of repair*

The roof seems to be in fair condition but needs a few minor repairs (*see photo 46*). The wooden structure of the front canopy is water-stained. The small section of gutter seems to be in fine working order.

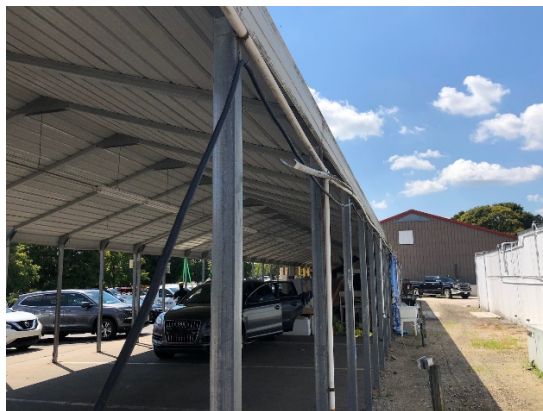
The Craft Shed is a steel framed, aluminum covered pre-fabricated shed. It measures 25 feet by 160 feet and covers 7,500 square feet. The shed has a flexible powerline running along the north side providing power for lights and tenants (*see photo 48*). The shed has multiple areas of surface damage (*see photo 49*).

*Photo 48 – Wiring and Conduit on shed*

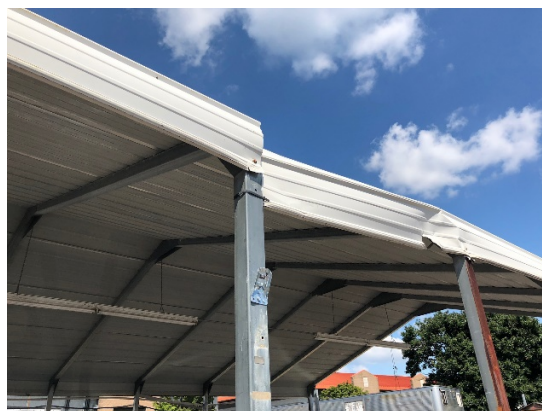
*Photo 49 – Damage to shed roof*

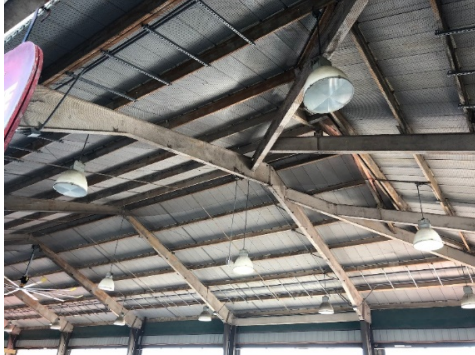
*Photo 51 – Condition of Exposed Roof Structure*

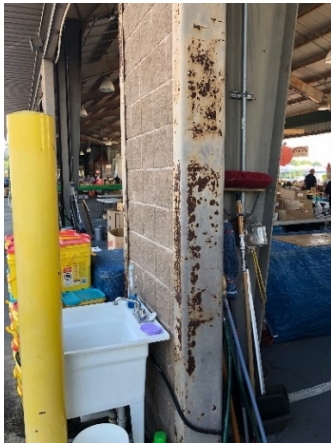
Block and mortar appear to be in good condition. Block shows signs of efflorescence in some locations (*see photo 53*). All exposed steel including casing for openings and steel roof structure should be treated and repainted (*see photos 51 and 52*). The finish on the metal siding is oxidizing and needs repainting.

*Photo 52 – Corrosion on Steel Casing*

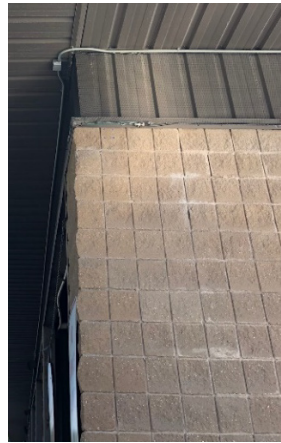
*Photo 53 – Efflorescence on block wall*

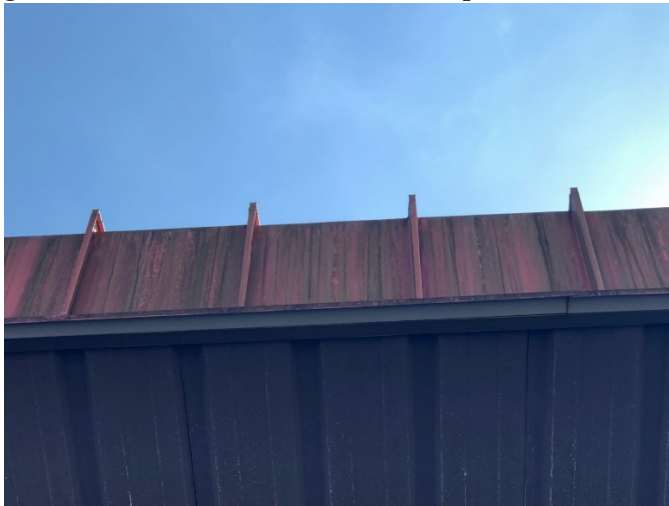
The color of the roof has faded from red to a peach-red color. The north face of the roof has organic growth that needs to be addressed (*see photo 34*).

*Photo 6 – Example of organic growth on roof and wear on soffit finish.*

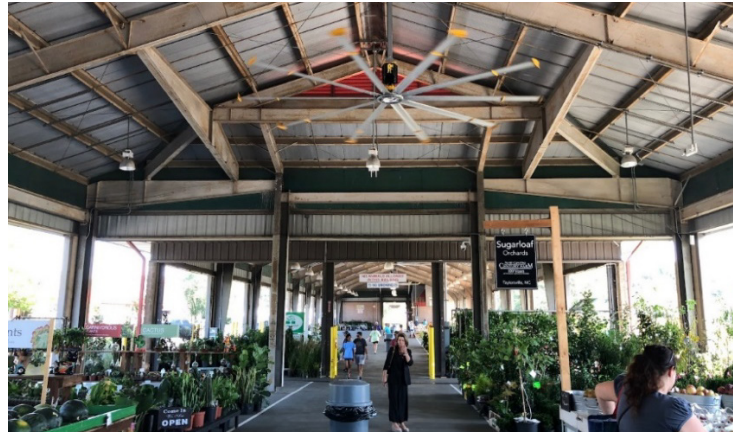
*Photo 58 – Interior finishes and fixtures*

The concrete finish on the floor is in overall good condition but is peeling in spots (*see photo 57*). The interior structure and exposed metal is oxidizing and needs to be treated and repainted (*see photo 58*). Restroom tile, fixtures, partitions, and walls are in good condition. The plywood siding on the restroom cores need to be treated for organic growth and repainted. The high-bay light fixtures are corroding and should be replaced with low-energy light fixtures.

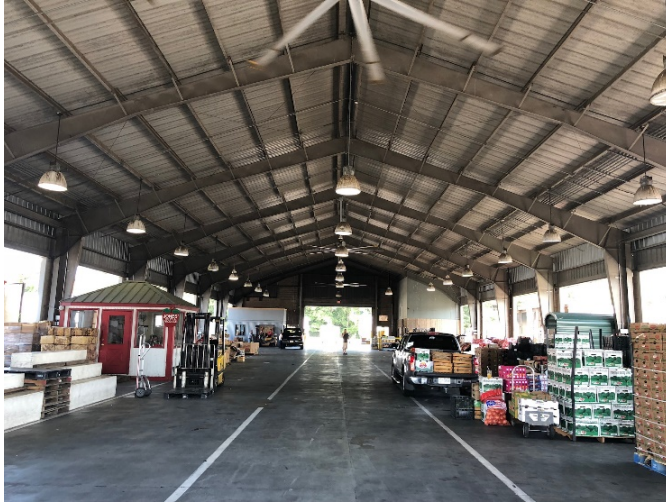
Block and mortar appear to be in good condition. Block shows significant organic growth and efflorescence in some locations (*see photo 60*). All exposed steel including casing for openings and steel roof structure need to be treated and repainted (*see photo 59*). All metal siding is fading and losing its finish and needs repainting.

*Photo 59 – Trucker's Shed Interior*
